**U.S. ENVIRONMENTAL PROTECTION AGENCY  
TECHNICAL ENFORCEMENT SUPPORT  
AT  
HAZARDOUS WASTE SITES**

**DRAFT PRELIMINARY REVIEW/  
VISUAL SITE INSPECTION REPORT  
CHEMICAL WASTE MANAGEMENT, INC.  
VICKERY, OHIO  
OHD 020 273 819**

**RCRA FACILITY ASSESSMENT  
U.S. EPA REGION V**

**MARCH 1991**

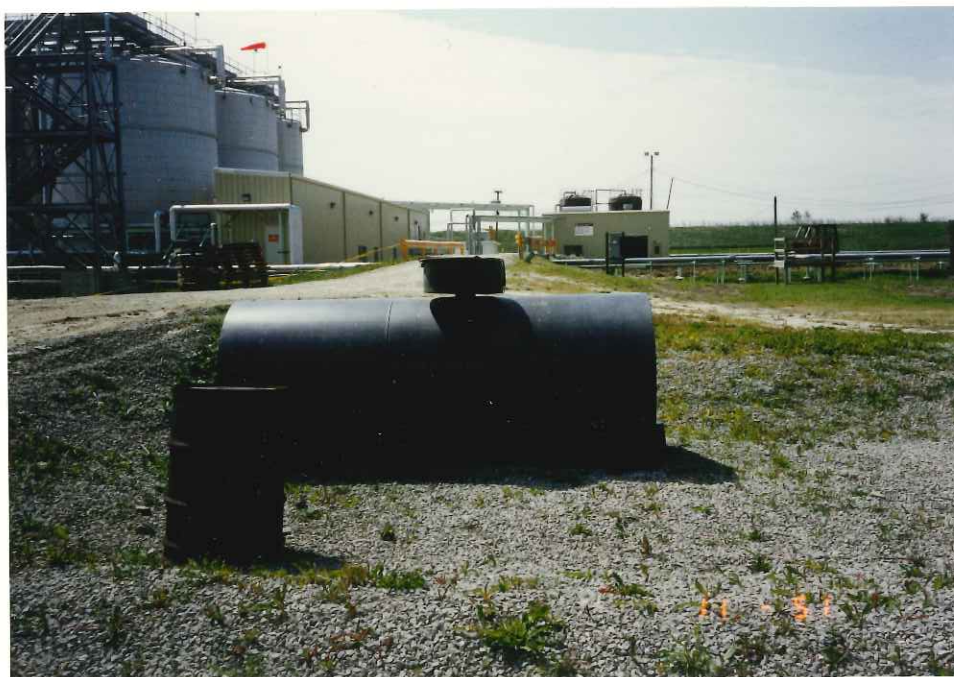
G. **VSI Observations**: No evidence of releases was observed (photograph #52).

PHOTOGRAPH #52  
 OFFICIAL PHOTOGRAPH - JACOBS ENGINEERING  
 SUBJECT: 1000 gallon Waste Oil Tank with gravel berm  
 LOCATION: Waste Oil Tank  
 DATE: 05/09/90                      TIME: 1151  
 PHOTOGRAPHER: L. Ehrhard  
 FILM: Kodacolor ASA 200  
 FILE: 10-E054-00  
 WITNESS: E. Gorove

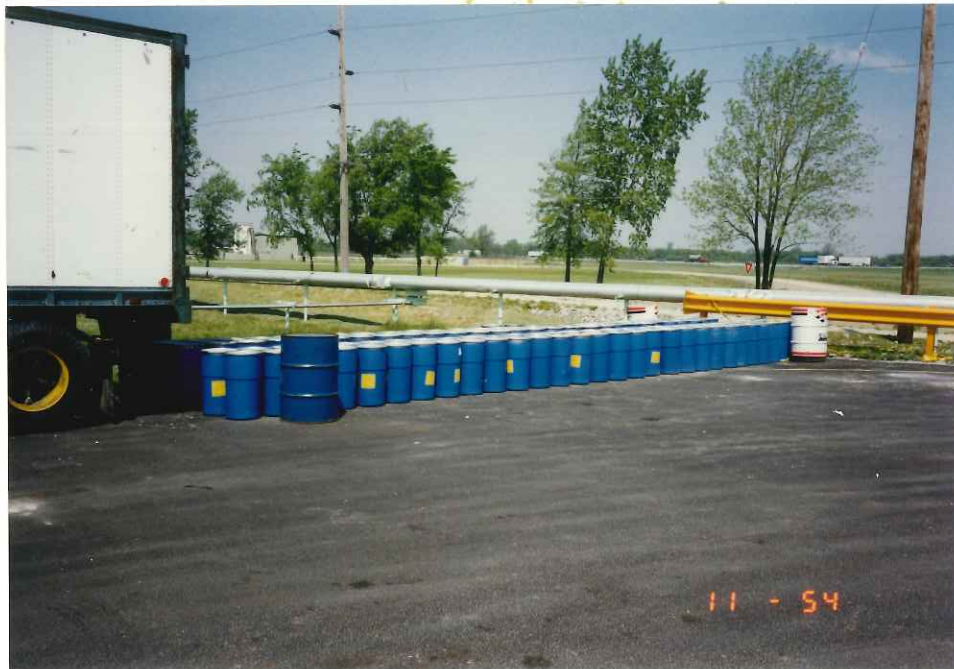
PHOTOGRAPH #53  
 OFFICIAL PHOTOGRAPH - JACOBS ENGINEERING  
 SUBJECT: Drummed hazardous waste on northwest corner of pavement  
 LOCATION: Truck Unloading Facility North Parking Lot  
 DATE: 05/09/90      TIME: 1154  
 PHOTOGRAPHER: L. Ehrhard  
 FILM: Kodacolor ASA 200  
 FILE: 10-E054-00  
 WITNESS: E. Gorove

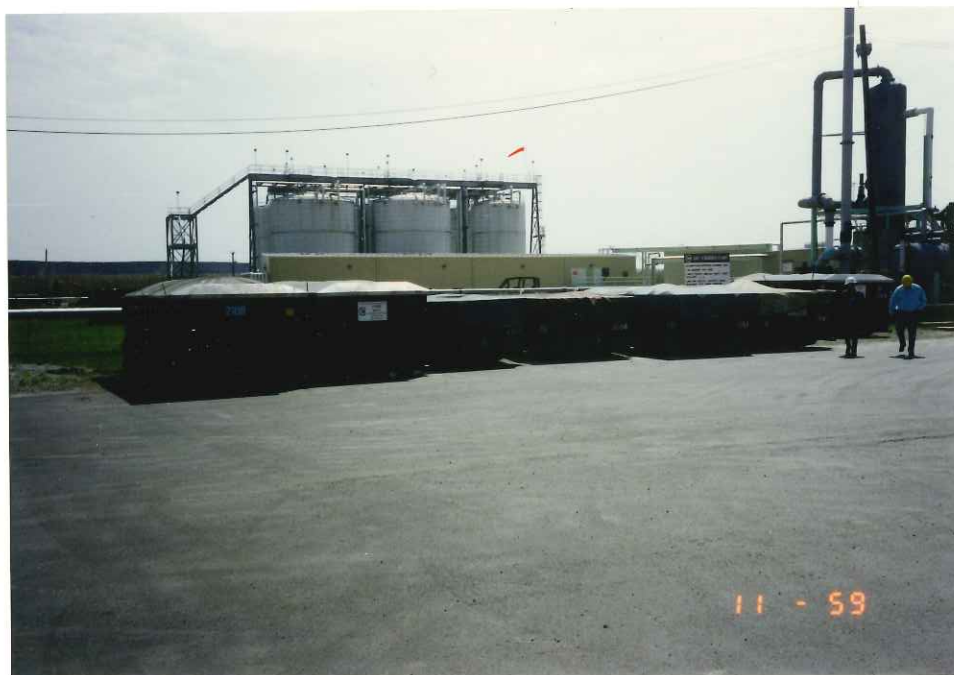
PHOTOGRAPH #54  
 OFFICIAL PHOTOGRAPH - JACOBS ENGINEERING  
 SUBJECT: Rolloff boxes of hazardous waste on east edge of pavement  
 LOCATION: Truck Unloading Facility North Parking Lot  
 DATE: 05/09/90      TIME: 1159  
 PHOTOGRAPHER: L. Ehrhard  
 FILM: Kodacolor ASA 200  
 FILE: 10-E054-00  
 WITNESS: E. Gorove

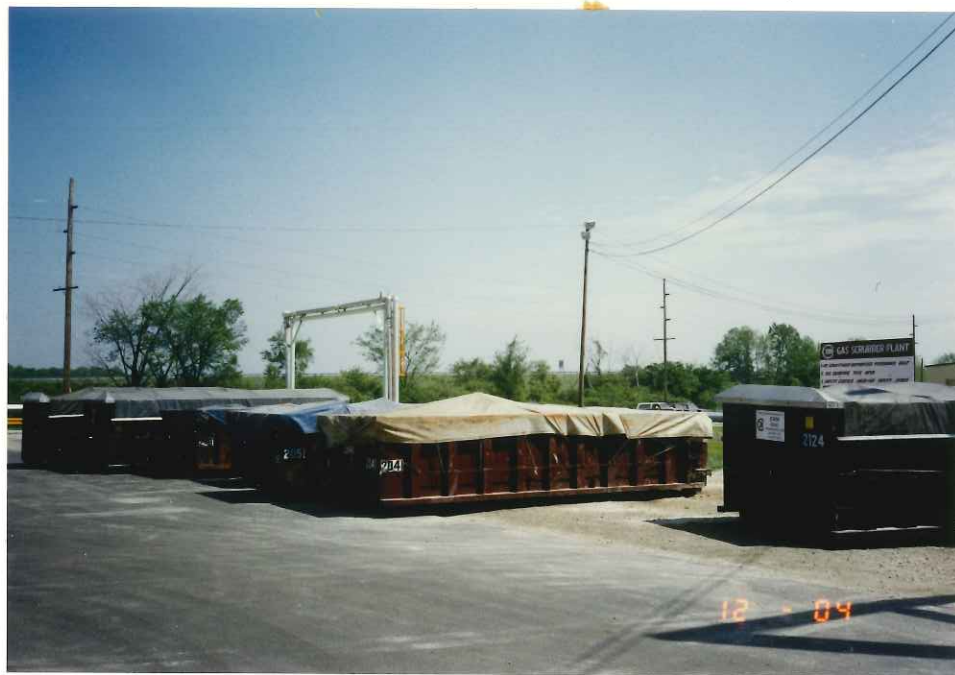
**PHOTOGRAPH #55**

- G. VSI Observations:** Rolloff boxes on east side of parking lot were resting off the pavement on soil. There was no grass underlying boxes (photographs #54 and #55). Drums at the northwest corner were on pavement (photograph #53). There was no evidence of spills or staining.

**SUBJECT:** Rolloff boxes of hazardous waste on east edge of pavement

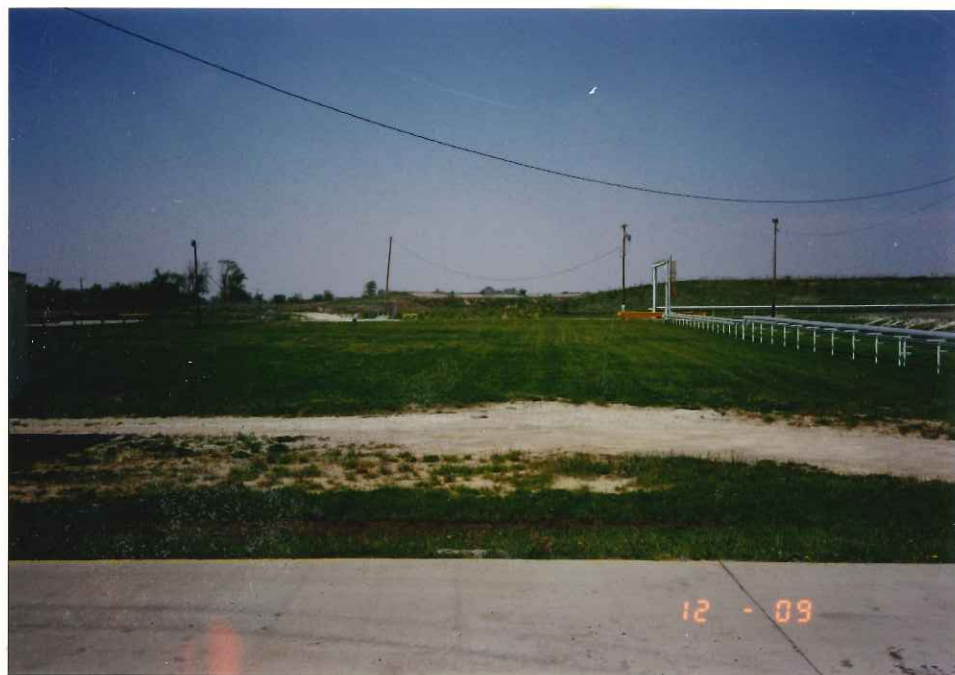
**PHOTOGRAPH #56**

- G. **VSI Observations:** Area is flat and covered with grass (photograph #56).
- H. **Sample Results:** No PCBs detected in soil samples. [8]
- I. **Suggested Further Actions:** No further action required.

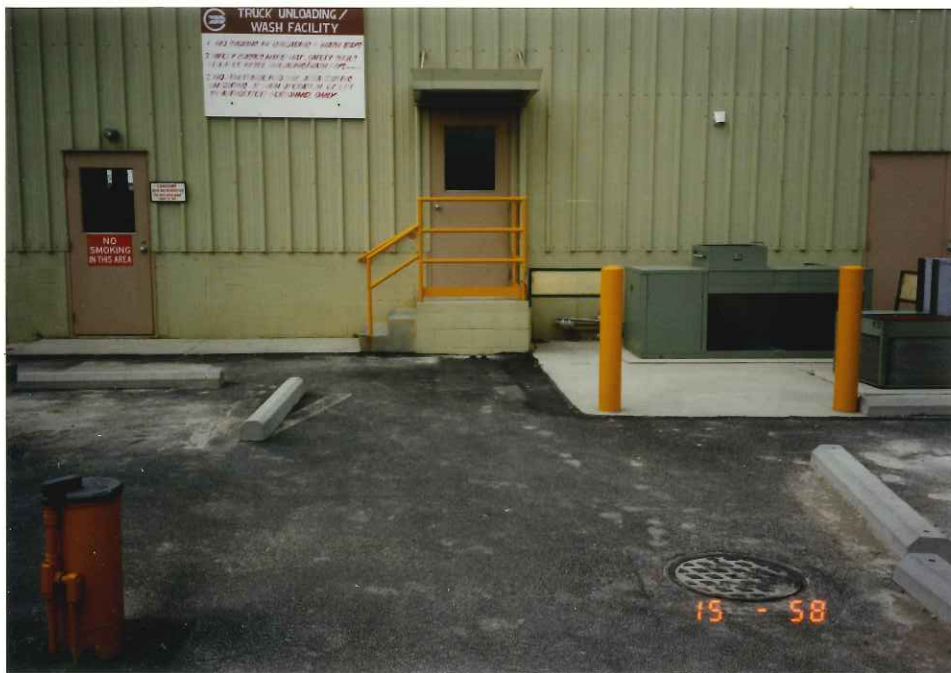
G. **VSI Observations:** No evidence of releases was observed (photograph #57)

PHOTOGRAPH #57  
 OFFICIAL PHOTOGRAPH - JACOBS ENGINEERING  
 SUBJECT: Manhole for underground Cesspit  
 LOCATION: Truck Unloading Facility Cesspit  
 DATE: 05/09/90                      TIME: 1558  
 PHOTOGRAPHER: L. Ehrhard  
 FILM: Kodacolor ASA 200  
 FILE: 10-E054-00  
 WITNESS: E. Gorove

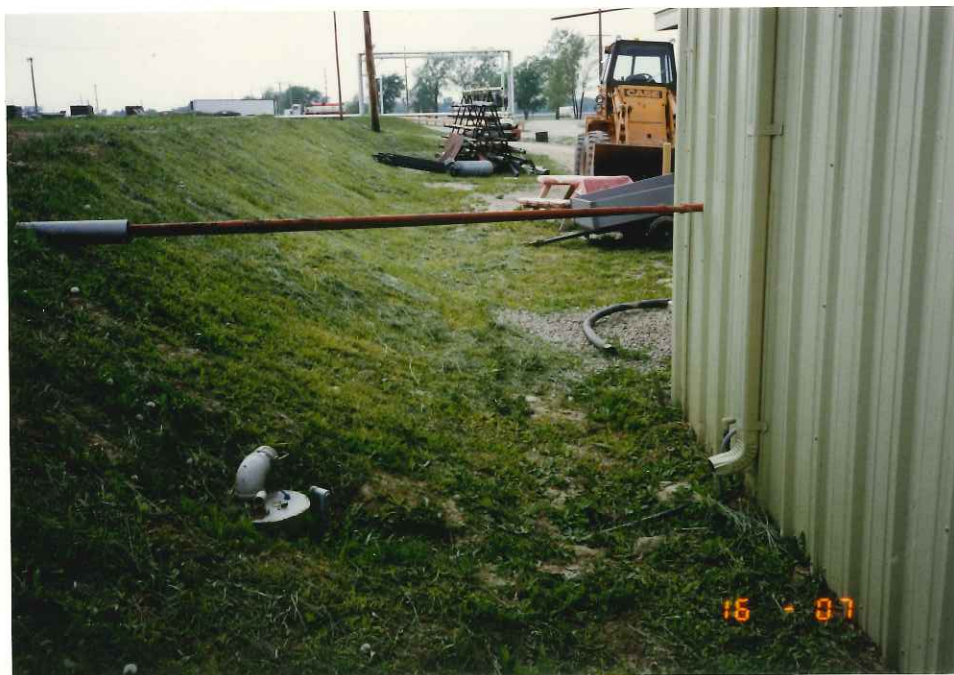
G. **VSI Observations:** No evidence of releases was observed (photograph #58).

PHOTOGRAPH #58  
 OFFICIAL PHOTOGRAPH - JACOBS ENGINEERING  
 SUBJECT: Hose hookup for underground cesspit  
 LOCATION: Maintenance Building Cesspit  
 DATE: 05/09/90                      TIME: 1607  
 PHOTOGRAPHER: L. Ehrhard  
 FILM: Kodacolor ASA 200  
 FILE: 10-E054-00  
 WITNESS: E. Gorove

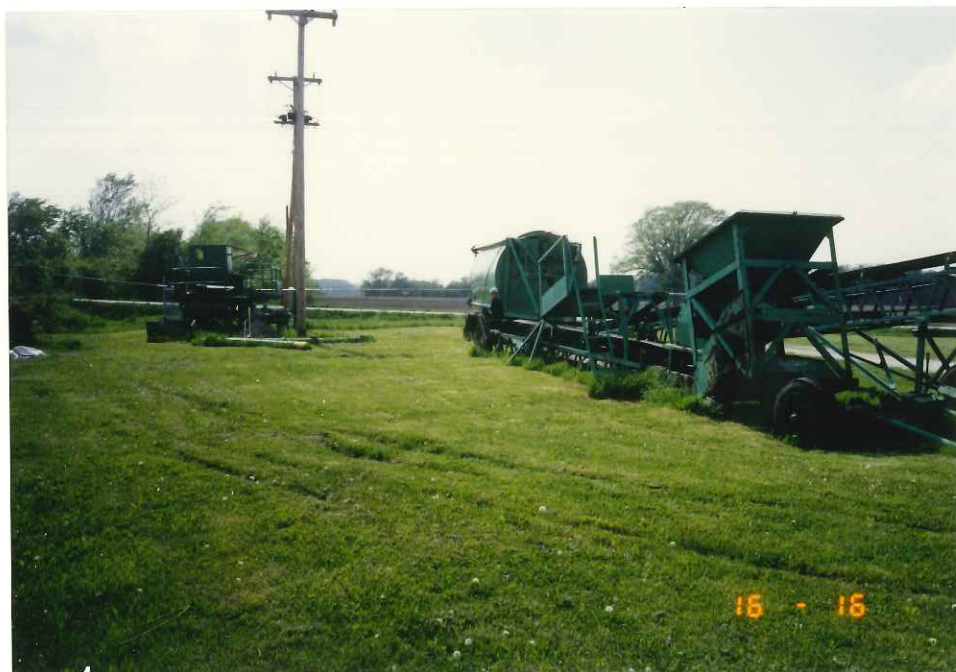
PHOTOGRAPH #59

**G. VSI Observations:** No evidence of releases was observed. One of the hoppers had "PCB" etched on its side (photographs #26 and #27). The Pug Mill is located on the west side of the area (photograph #59).

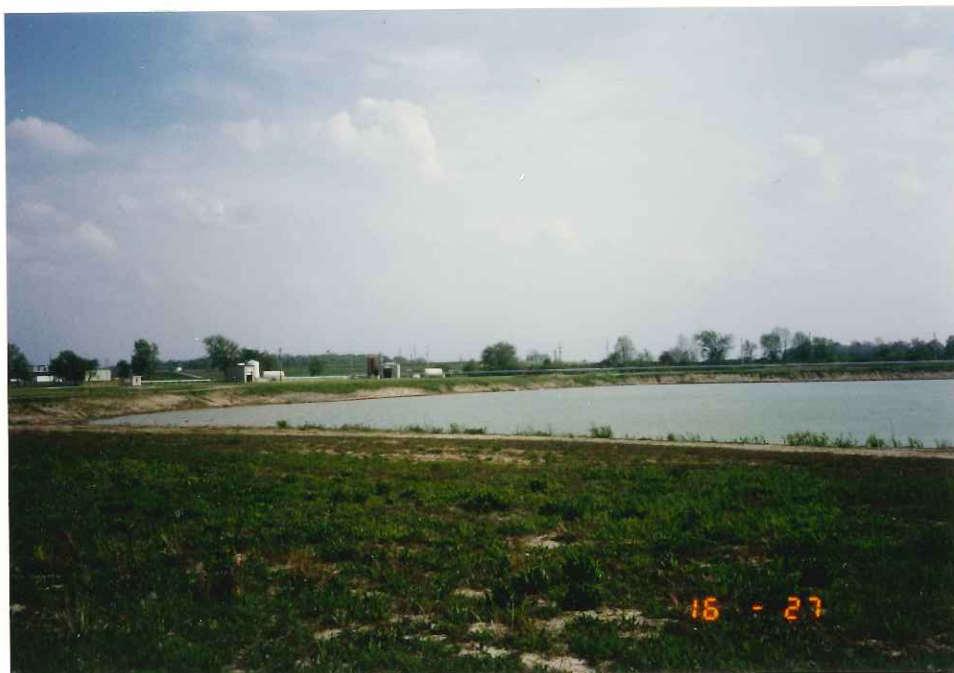
PHOTOGRAPH #60

**G. VSI Observations:** Borrow Pit 2 is a large pit which is currently filled with water. No stressed vegetation or debris in the pit was noted. CWM personnel indicated that to their knowledge, no hazardous wastes were disposed of in the borrow pits (photographs #60, #61, and #62).

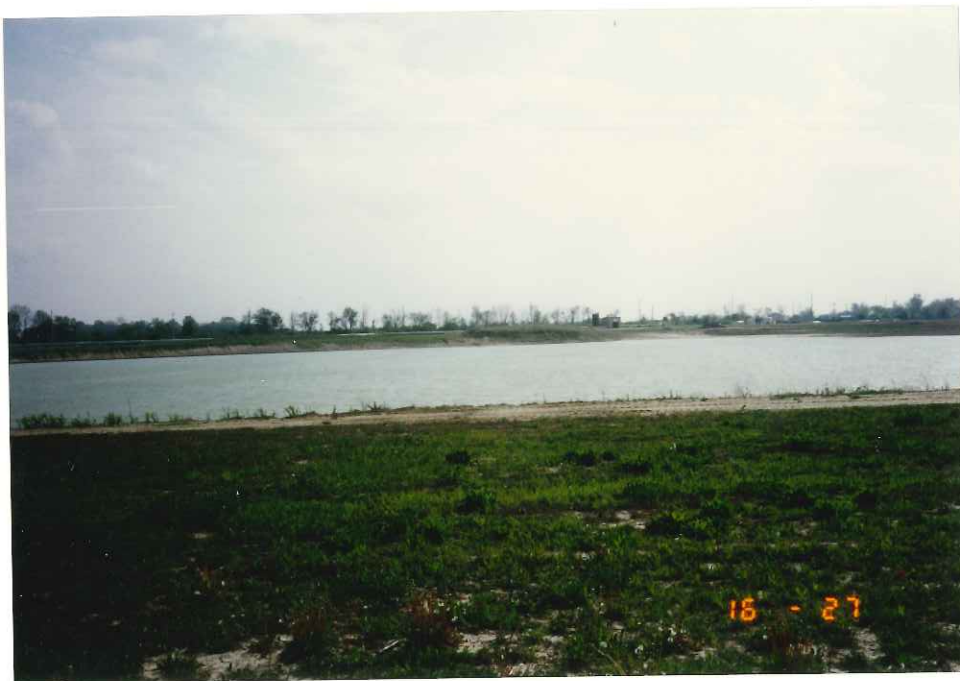
OFFICIAL PHOTOGRAPH - JACOBS ENGINEERING  
 SUBJECT: Center of Borrow Pit #2 as seen from the north side  
 LOCATION: Borrow Pit #2  
 DATE: 05/09/90 TIME: 1627  
 PHOTOGRAPHER: L. Ehrhard  
 FILM: Kodacolor ASA 200  
 FILE: 10-E054-00  
 WITNESS: E. Gorove

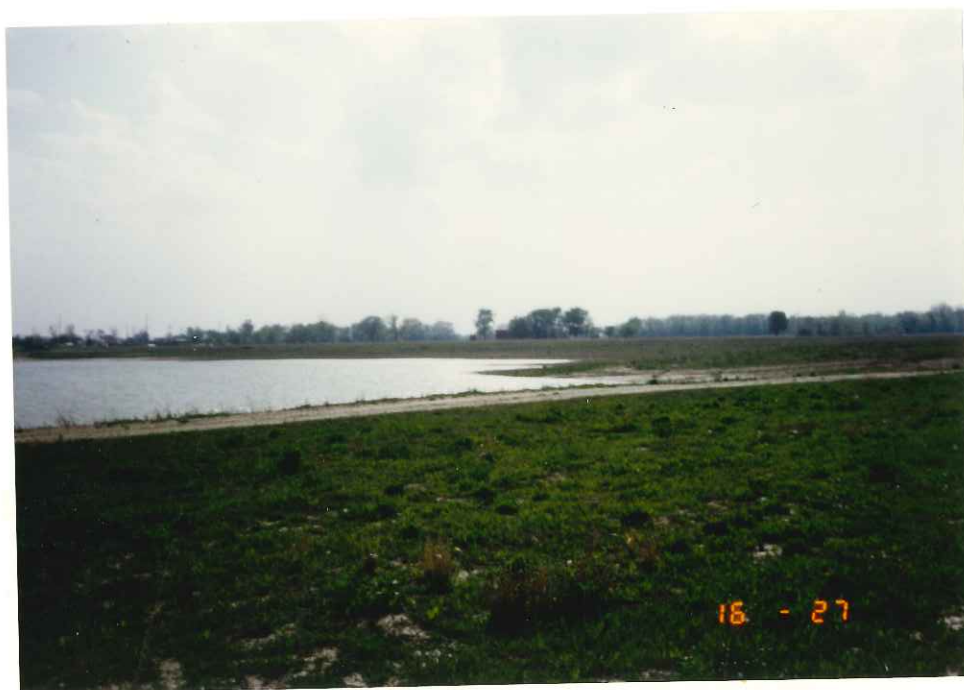
OFFICIAL PHOTOGRAPH - JACOBS ENGINEERING  
 SUBJECT: West side of Borrow Pit #2 as seen from the north side  
 LOCATION: Borrow Pit #2  
 DATE: 05/09/90 TIME: 1627  
 PHOTOGRAPHER: L. Ehrhard  
 FILM: Kodacolor ASA 200  
 FILE: 10-E054-00  
 WITNESS: E. Gorove

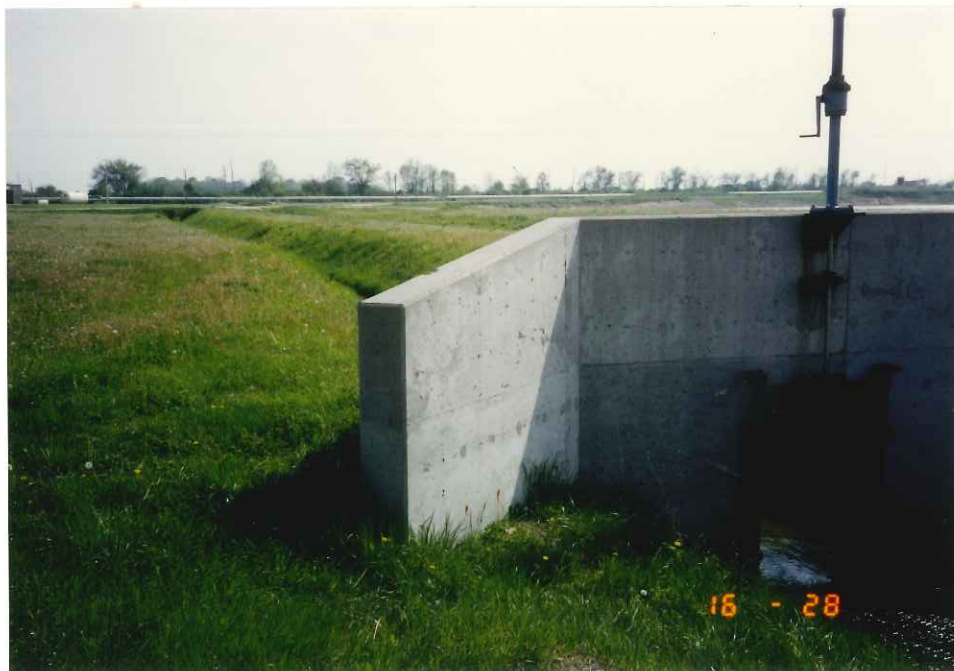
A Surface Water Management Plan, approved by OEPA, has been implemented at the facility. The plan consists of bermed areas and flood gates which can be closed in the event of major spills (photo #63). [3]

PHOTOGRAPH #63  
 OFFICIAL PHOTOGRAPH - JACOBS ENGINEERING  
 SUBJECT: Meyers Creek outlet gate at north side of facility property  
 LOCATION: Meyer Creek  
 DATE: 05/09/90                      TIME: 1628  
 PHOTOGRAPHER: L. Ehrhard  
 FILM: Kodacolor ASA 200  
 FILE: 10-E054-00  
 WITNESS: E. Gorove

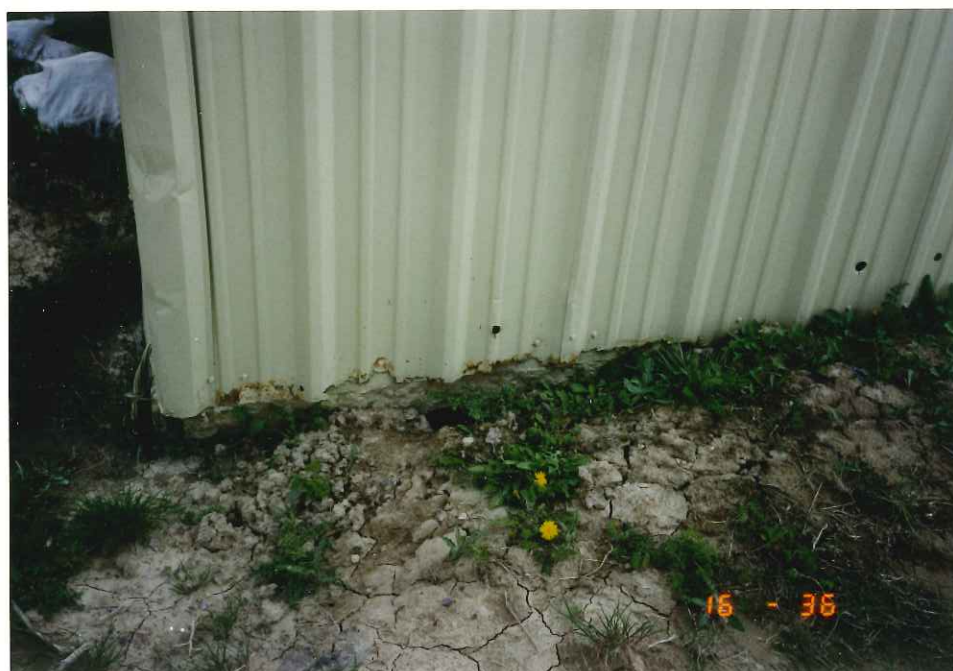
PHOTOGRAPH #64  
 OFFICIAL PHOTOGRAPH - JACOBS ENGINEERING  
 SUBJECT: Corrosion at northeast corner of Storage Building  
 LOCATION: Oil Reclamation Facility Storage Building  
 DATE: 05/09/90                      TIME: 1636  
 PHOTOGRAPHER: L. Ehrhard  
 FILM: Kodacolor ASA 200  
 FILE: 10-E054-00  
 WITNESS: E. Gorove
